# Lead Inspection Report For 117-129 Whalley Avenue

New Haven, CT

EnviroMed Project # IH-24-2288

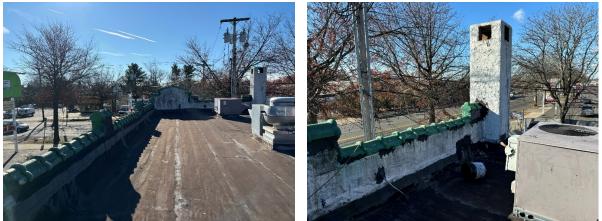
Figure 3. XRF Readings 12304 to 1306, on the roof (green paint on parapet), were found to have lead readings of 6.3 mg/cm<sup>2</sup> to 10.7 mg/cm<sup>2</sup>

Green Clay Roof Tile - Exterior Roof Parapet - 29.3 mg/L of lead

The Green Clay Roof Tile leaches lead in excess of 5 mg/L, classifying it as hazardous lead waste.
